Casualty Investigations

Gambling with Safety

Allision of a towing vessel.

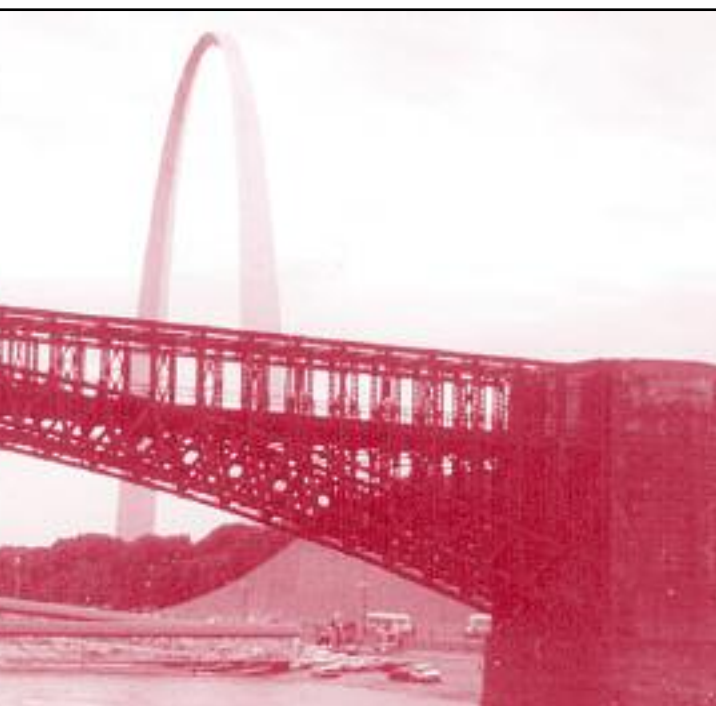
Shortly thereafter though, one or more barges allided with the *Admiral*’s bow and another struck an entrance ramp, breaking the walkway loose from its moorings. Several people on the ramp were quickly evacuated off, all of them successfully reaching the Missouri bank seconds before the ramp sank. With eight of its 10 mooring lines now parted, the *Admiral* began to rotate clockwise downriver away from the Missouri bank.

broadcast urgent messages to the *Anne Holly*, informing it of the path of lost barges. Upon hearing the messages, the captain quickly released the remaining barges, turned the tow around, and raced downriver placing the bow against the *Admiral* as its next-to-last mooring line parted. The vessel actually transited about 500 feet downriver, but the combined efforts of the *Anne Holly* and the last remaining mooring wire successfully held the vessel near the Missouri bank.

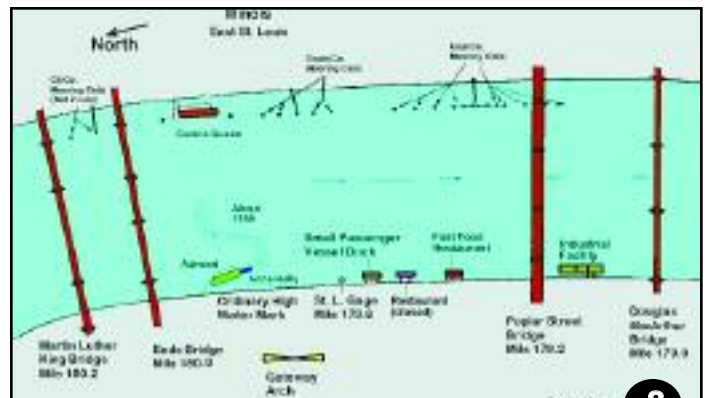
7

The captain releases the remaining barges, turns the towboat around, and places the bow against the *Admiral* as the casino’s next-to-last mooring line parts. Photos courtesy NTSB.
